# City of Elkins

## Asbestos Inspection Report

414 Harpertown Road

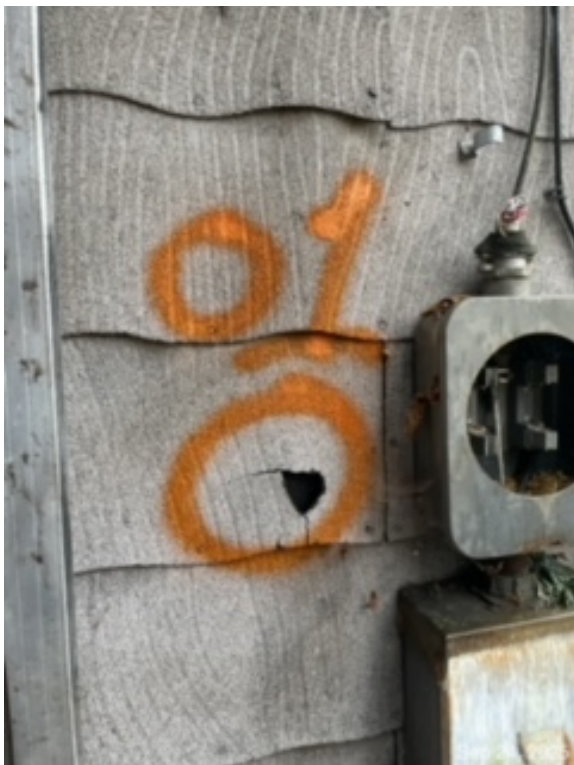
**Sample 01**

| Client ID | Lab ID | Layer | Sample Description | Asbestos % |
|---|---|---|---|---|
| 01 | 3769058 | | Black/gray siding | None Detected |

| Client ID | Lab | Lab | NON-ASBESTOS COMPONENTS | | | ASBESTOS |
|---|---|---|---|---|---|---|
| 01<br>3769058 | Siding | Heterogeneous<br>Black/gray<br>Fibrous<br>Bound | 50% | Cellulose 40%<br>Tar 10% | Gravel | None Detected |

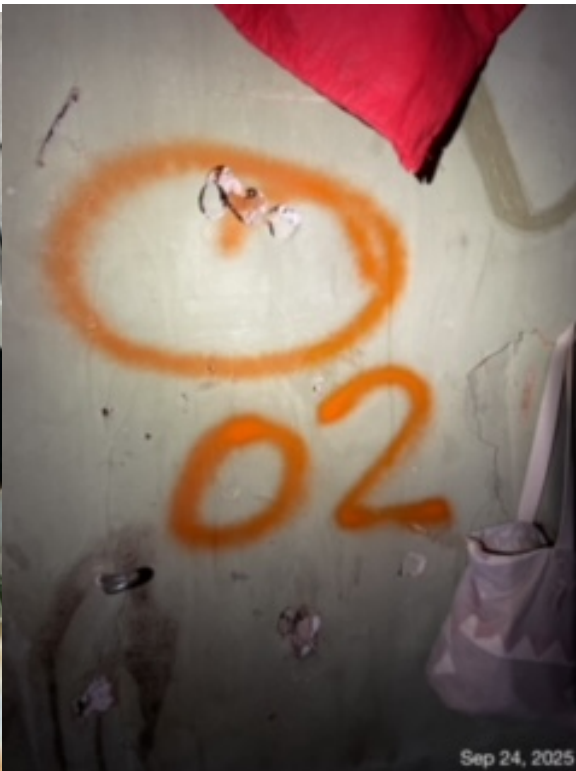
**Sample 02**

| Client ID | Lab ID | Layer | Sample Description | Asbestos % |
|---|---|---|---|---|
| 02 | 3769059 | | Gray drywall | None Detected |

| Client ID | Lab | Lab | NON-ASBESTOS COMPONENTS | | | ASBESTOS |
|---|---|---|---|---|---|---|
| 02<br>3769059 | Drywall | Heterogeneous<br>Gray<br>Fibrous<br>Bound | 20% | Cellulose 75%<br>Gypsum 5% | Paint | None Detected |
| No plaster present. Sample appears to be drywall. | | | | | | |

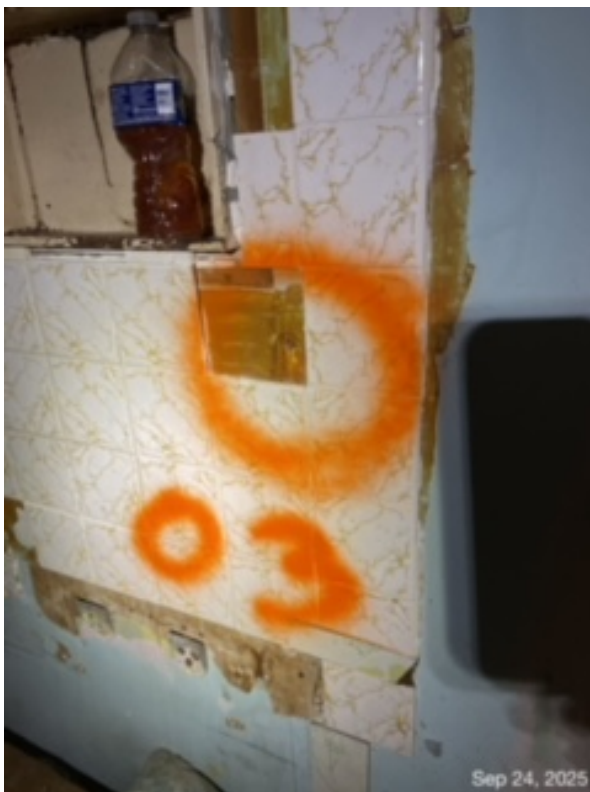
**Sample 03**

| Client ID | Lab ID | Layer | Sample Description | Asbestos % |
|---|---|---|---|---|
| 03 | 3769060 | | Beige/gold tile | None Detected |

| Client ID | Lab | Lab | NON-ASBESTOS COMPONENTS | | | ASBESTOS |
|---|---|---|---|---|---|---|
| 03<br>3769060 | Tile | Homogeneous<br>Beige/gold<br>Non-Fibrous<br>Bound | | 80%<br>Binder 20% | Silica | None Detected |

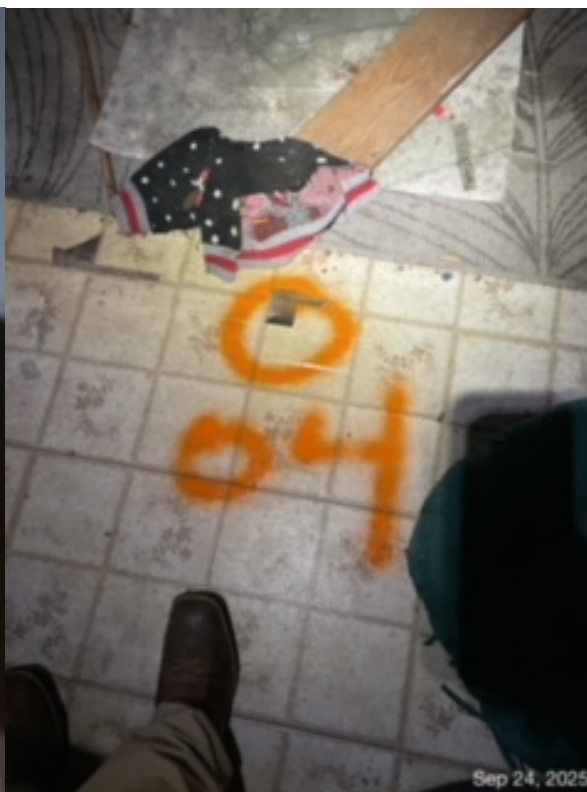
**Sample 04**

| Client ID | Lab ID | Layer | Sample Description | Asbestos % |
|---|---|---|---|---|
| 04 | 3769061 | | Tan sheet vinyl | None Detected |
| 04 (2) | 3785150 | | Yellow mastic | None Detected |

| Client ID | Lab | Lab | NON-ASBESTOS COMPONENTS | | | ASBESTOS |
|---|---|---|---|---|---|---|
| 04<br>3769061 | Sheet Vinyl | Homogeneous<br>Tan<br>Non-Fibrous<br>Bound | | 100% | Vinyl | None Detected |
| 04 (2)<br>3785150 | Mastic | Homogeneous<br>Yellow<br>Non-Fibrous<br>Bound | | 100% | Mastic | None Detected |

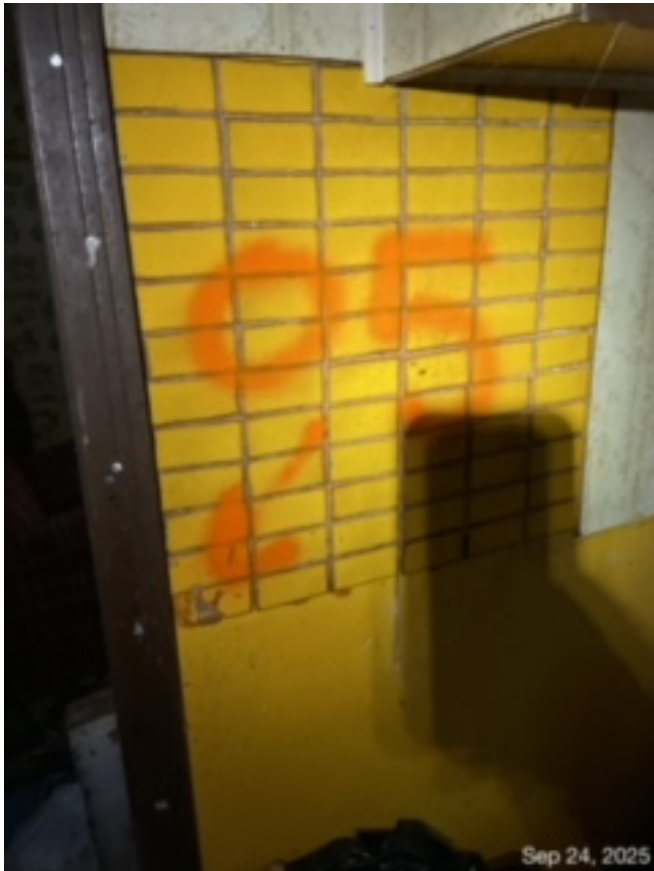
**Sample 05**

| Client ID | Lab ID | Layer | Sample Description | Asbestos % |
|---|---|---|---|---|
| 05 | 3769062 | | Yellow tile | None Detected |
| 05 (2) | 3785181 | | Yellow mastic | None Detected |

| Client ID | Lab | Lab | NON-ASBESTOS COMPONENTS | | | ASBESTOS |
|---|---|---|---|---|---|---|
| 05<br>3769062 | Tile | Homogeneous<br>Yellow<br>Non-Fibrous<br>Bound | | 80%<br>Binder 20% | Silica | None Detected |
| 05 (2)<br>3785181 | Mastic | Homogeneous<br>Yellow<br>Non-Fibrous<br>Bound | | 100% | Mastic | None Detected |

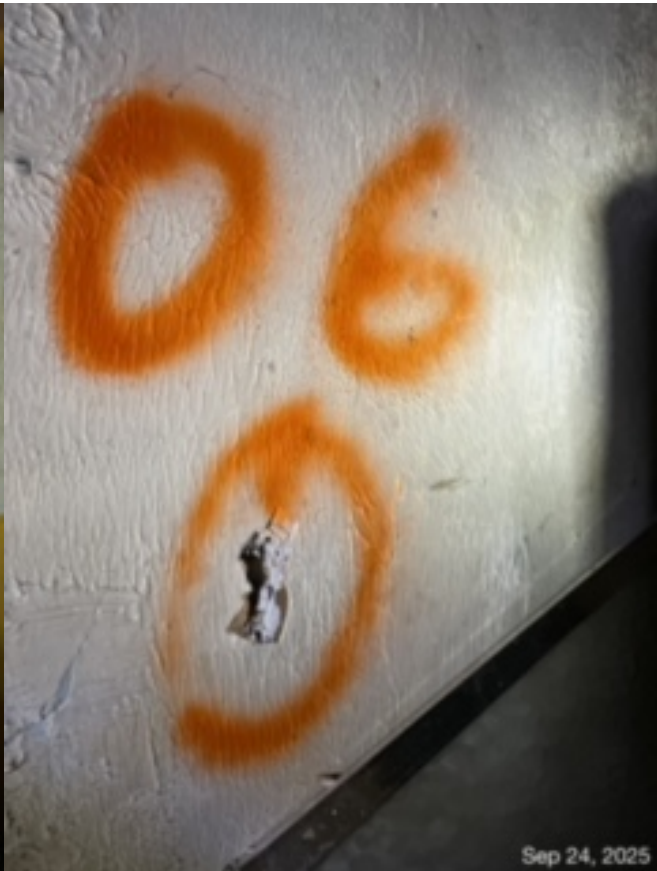
**Sample 06**

| Client ID | Lab ID | Layer | Sample Description | Asbestos % |
|---|---|---|---|---|
| 06 | 3769063 | Layer A | White texture | None Detected |
| | | Layer B | Gray drywall | None Detected |

| Client ID | Lab | Lab | NON-ASBESTOS COMPONENTS | | | | ASBESTOS |
|---|---|---|---|---|---|---|---|
| 06 | Texture | Heterogeneous | | 65% | Binder | | None Detected |
| Layer B | Drywall | Heterogeneous | 20% | Cellulose | 80% | Gypsum | None Detected |
| No plaster present. Sample appears to be texture and drywall. | | | | | | | |

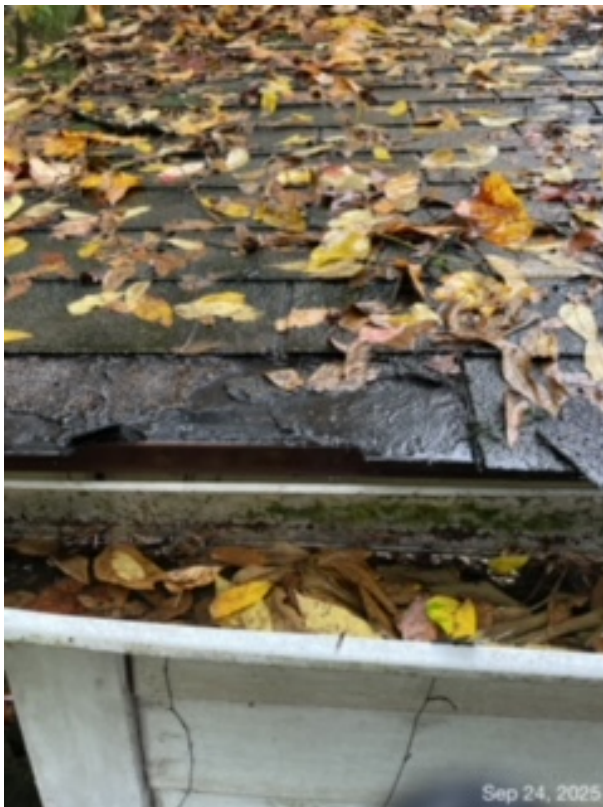
**Samples 07, 08, 09**

| Client ID | Lab ID | Layer | Sample Description | Asbestos % |
|---|---|---|---|---|
| 07 | 3769064 | | Black shingle | None Detected |
| 08 | 3769065 | | Black shingle | None Detected |
| 09 | 3769066 | | Black underlayment | None Detected |

| | | Bound | | | | | |
| --- | | | | | | | |
| 07 | Shingle | Heterogeneous | 50% | Glass | 40% | Tar | None Detected |
| 08 | Shingle | Heterogeneous | 50% | Glass | 40% | Tar | None Detected |
| 09 | Underlayment | Homogeneous | 70% | Cellulose | 30% | Tar | None Detected |
